(SB-0001 Gas Tank Grommet failure) - As reported by Kasperwing pilot

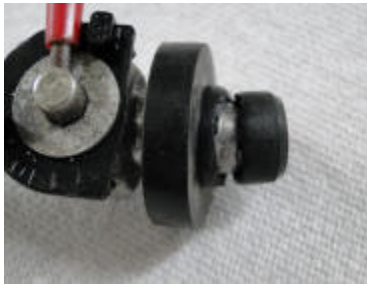
the rubber grommet that connects the fuel line petcock to the gas tank had failed. While the fuel line was still (barely) in place this failure would allow the fuel line to COMPLETELY separate from the tank making for an IMMEDIATE dead-stick landing "wherever". What I am doing now is to connect my fuel line to the tank using a "bulkhead" type of connector I found at a local marine store. I suggest you all check yours and make the appropriate repairs.

Failed Grommet

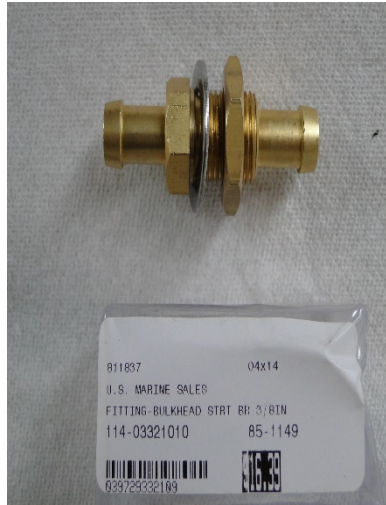
Recommended Replacement
